febiEXAKT

Alternator Coupling Pulley Kit

febi no. 30816

**VW Touareg, Multivan T5, Transporter T5
with 2.5 TDI and 5.0 TDI engines**

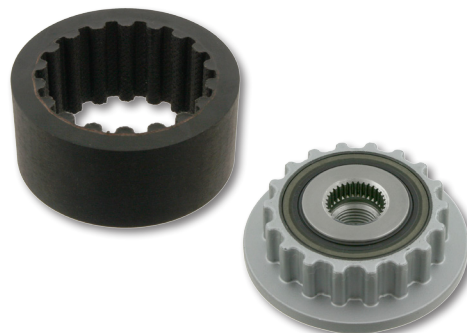
Severe vibrations and unusually loud noises in the ancillary drive area may be the warning signs of imminent failure of the freewheeling alternator pulley.

The alternator coupling transfers the torque to the alternator and air-conditioning compressor to dampen vibrations between the connected shafts. Belt alignment and service intervals are critical in this respect, when replacing the alternator freewheel and the alternator coupling, the alternator and/or air-conditioning compressor should also be removed. The alternator is fitted together with a bracket. If both components are separated, after fitting, the alternator becomes misaligned. The result is that the alignment is no longer correct and the alternator coupling can break. (see Fig. 1). However, a defective alternator freewheel can also cause damage, it causes the alternator coupling to be overloaded, which can lead to it breaking.

As the alternator should not be separated from the bracket, it should be removed and fitted complete with bracket during repairs. febi bilstein strongly recommends paying close attention to the service intervals for the alternator freewheel and alternator coupling: in vehicles without diesel particulate filters (DPF), this replacement should take place every 150,000 km, and in those with DPF, every 180,000 km.

febi bilstein also advises that the alternator freewheel should always be replaced at the same time as changing the alternator coupling. We therefore offer the coupling along with alternator freewheel in a complete kit (febi no. 30816/Repl. no. 070 903 201 E S1). Alternator freewheel (febi no. 26958/Repl. no. 070 903 201 C) and coupling (febi no. 30798/Repl. no. 070 903 327 D) are available individually.
