Important instructions on the replacement of the water pump kits 8MP 376 809-881 and 8MP 376 810-891

AUDI / VW 2.5 TDI V6

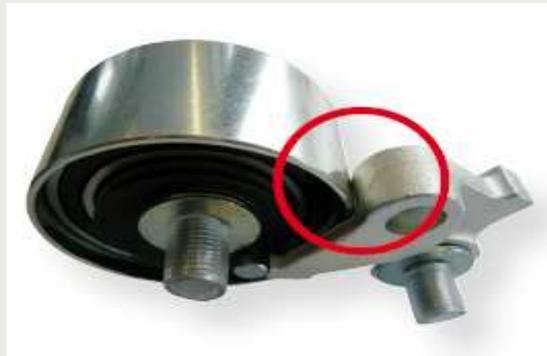
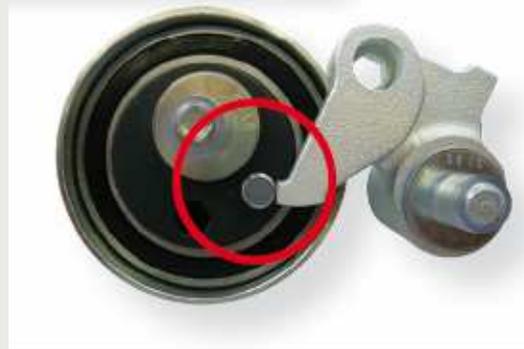
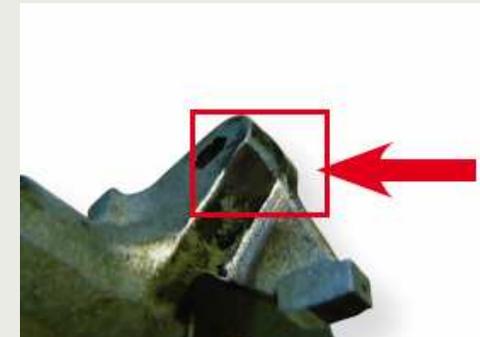
If the tensioner (see pictures) 9XU 376 818-511 is not mounted correctly, it may drag on the tensioner pulley 9XU 376 819-661, which can lead to the deterioration of these components, through to a consequential engine damage.
