# Technical Bulletin

## Mazda 6 Estate - Luggage Cover Repair Kit

Applicable References: ADM58067

Applications: Mazda 6 Estate 2002>2008

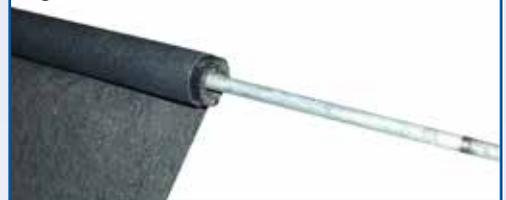
Fig. 2

- Firstly remove the LH (passenger side) plastic cover which is retained by two cross-head screws. (Figure 1)
- Now lift the retractable cover from the housing. What you have is the leatherette cover bonded to a metal tube with a coiled spring hooked onto a plastic sleeve attached to a metal rod, running through the centre. (Figure 2)
- The plastic sleeve is located on the end that the metal rod protrudes. To enable the sleeve to be removed you must now carefully peel back some of the leatherette cover until the two indentations on the metal tube are visible. These indentations are crimping the sleeve in place. (Figures 3)
- Next you must carefully drill out these two indents using a 2.5>3mm bit. Once drilled out, carefully twist and pull the plastic sleeve to gentle ease it from the metal tube. (Figures 4 & 5)

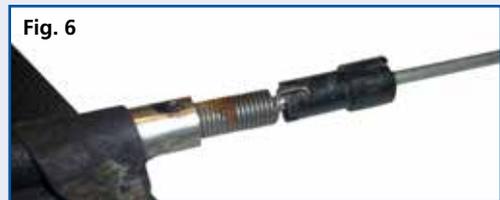
- Now the cause of the problem becomes evident. The 'L' shaped part of the plastic sleeve that the spring locates into will be worn, split or cracked. Figure 6 is of a working luggage cover, although wear is still evident so it'll only have been a matter of time!
