Anti-roll bar kits with mounts and connecting rods

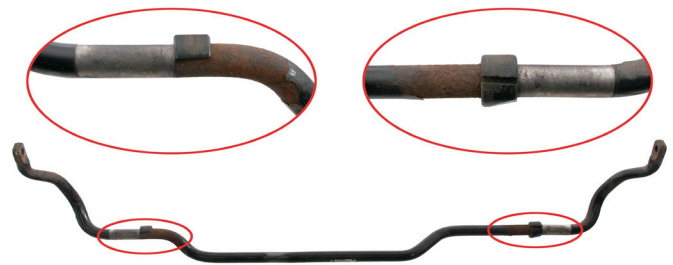
Fig. 1

Road debris, road salt and other external factors are frequent causes of damage to the anti-roll bar's coating (see Fig. 1). The worn coating of the anti-roll bar often gives rise to squeaking noises.

When the anti roll paint protection is damaged around the mounting points, always replace the anti-roll bar along with the rubber mounts.
