Technical Bulletin

Kia Sedona Clutch Kit Replacement

Applicable References: ADG03035 / ADG03058 / ADG03325

Applications: Kia Sedona 2.9DT 1999>2006

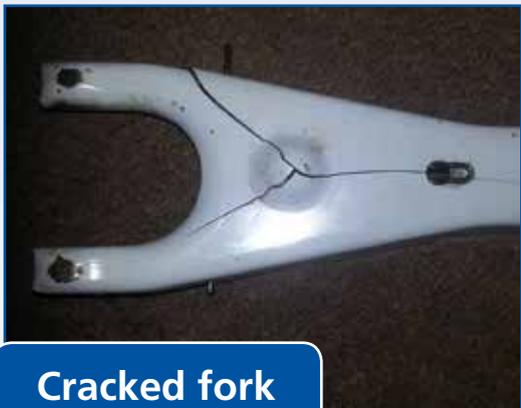
We have found that the cause of the problem can lie with a crack in the clutch release fork, as the release fork on this model can fracture and flex during operation and not allow the clutch to fully disengage.

Cracked fork

It is highly recommended that the clutch release fork is replaced during the clutch replacement process. Failure to change the fork could cause clearance problems and difficulty in selecting gears. This would not be covered under the Blue Print warranty agreement.
