VKJA 3867

Technical Bulletin - August 2010

Technical Information: VKJA 3867 Replacement guidelines

This bulletin describes the replacement guidelines of a wheel side CV-Joint on a Toyota AVENSIS 1.8 (AT221 model).

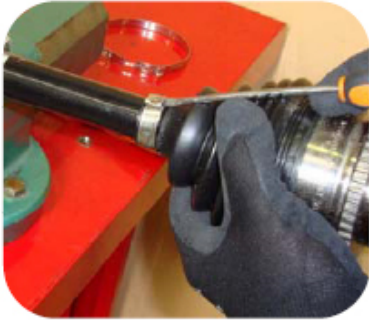
2. Place the driveshaft in a vice (with aluminum or protective jaws). Remove both the inner and the outer clips. Then, cut the boot and remove it.

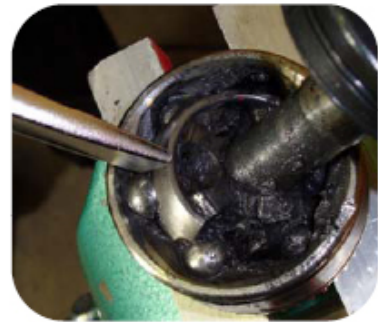
3. Place the CV-Joint bell in the vice. Then break the cage, in several positions along the edge (close to the balls) using a hammer and chisel.

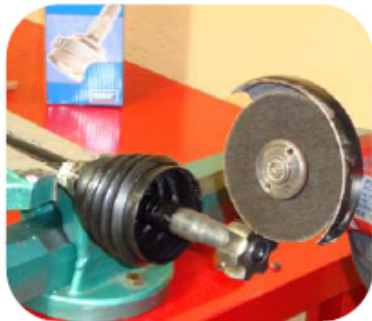
4. Cut the tracks of the inner race, in 2 or 3 positions by using a suitable cutting tool.

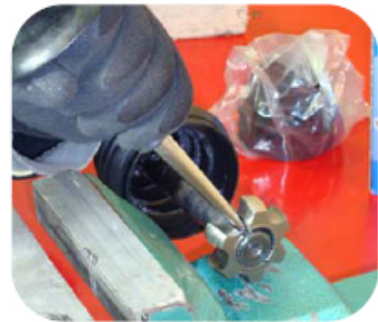
5. Break the inner race (use the hammer and chisel), focusing on the cuts previously made.

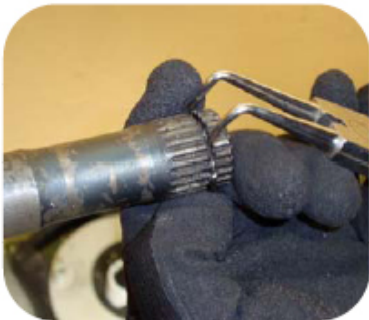
6. Expand and remove the circlip with circlip removal pliers.

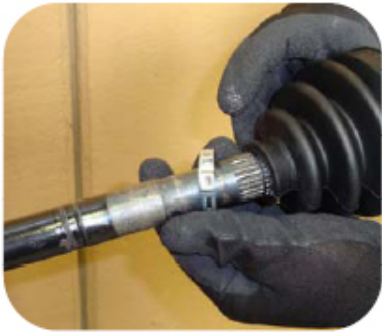
1. Put the short boot clamp on the shaft.
Slide the boot onto the shaft.

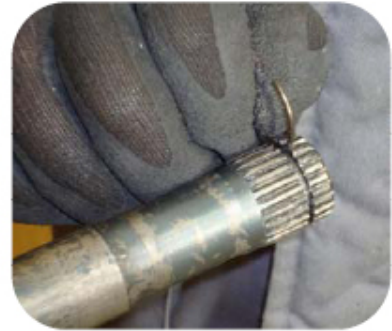
2. Fix the new circlip into the groove.
Tip: To keep it into the groove use a hose clip (do not over tighten!)

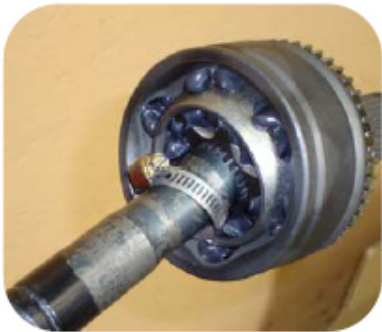
3. Press the new CV-Joint onto the shaft.
Tap with a rubber hammer until the circlip locks into its groove in the inner race of the CV-Joint.
Remove the hose clip.

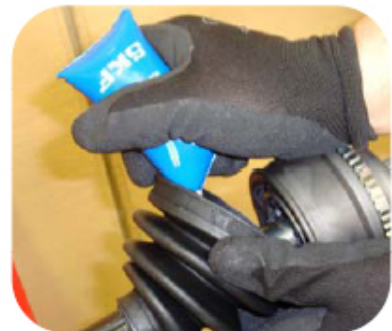
4. Slide the boot into position ready for mounting and fill with all of the supplied grease.

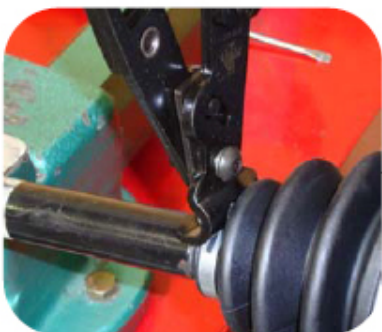
5. Fit the short and long clamps onto the CV-Joint boot and tighten them with a suitable tool.
